Report Date: January 10, 2001  
Date Submitted: January 10, 2001  
MEE Project: AB0004  
Sample ID: Fractured Wire

**PROJECT TITLE:** Evaluation of Device Wire Fracture**INTRODUCTION**

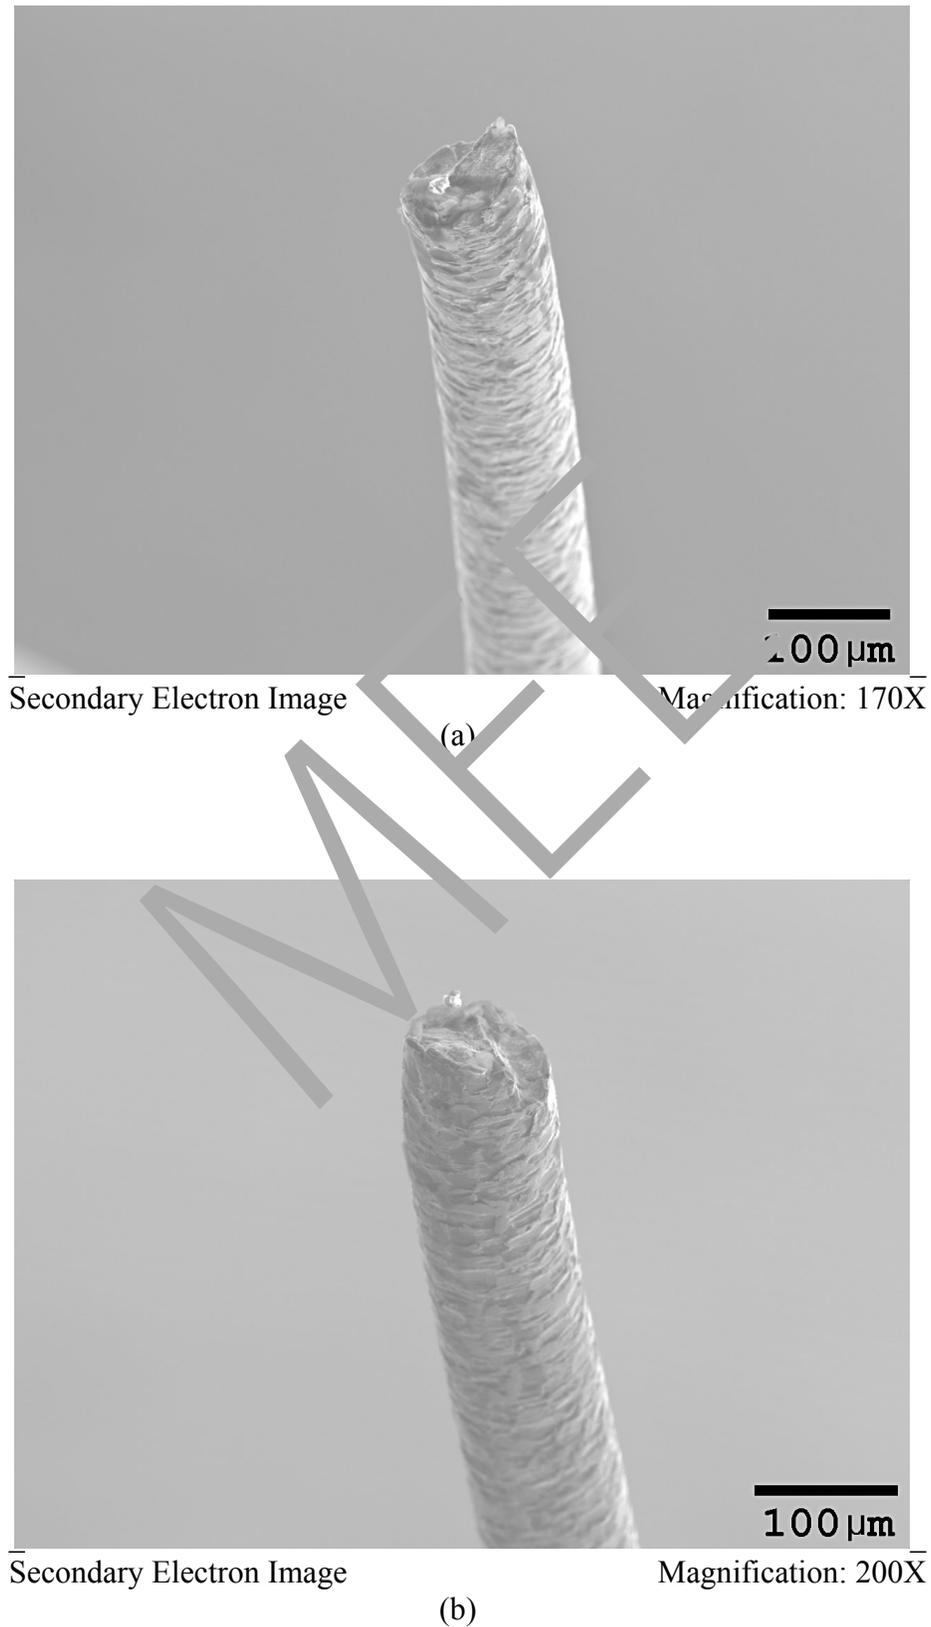
The texture of the original wire surface adjacent to the fracture was rough and somewhat smeared. The appearance and circumferential orientation of the surface texture was typical of centerless ground stainless steel wire. The circumferential grooves from centerless grinding create stress concentration sites that will accelerate the initiation of fatigue fracture in the wire. The grinding grooves are quite coarse relative to the small diameter of the wire, which creates a substantial concentration for bending and tensile stresses.

The wire had a distinct bend immediately at the fracture, Figures 1 and 2. The fracture was generally transverse to the wire's longitudinal axis. Other than the bend, there was no significant plastic deformation, such as necking or twisting of the wire, at the fracture.

The surface texture of the wire near the fracture consisted of circumferential grooves and smeared metal typical of the surface finish obtained by centerless grinding, Figure 1. No secondary cracks were detected in the wire surface near the fracture.

Figure 1 SEM images of the fractured end of the device wire.

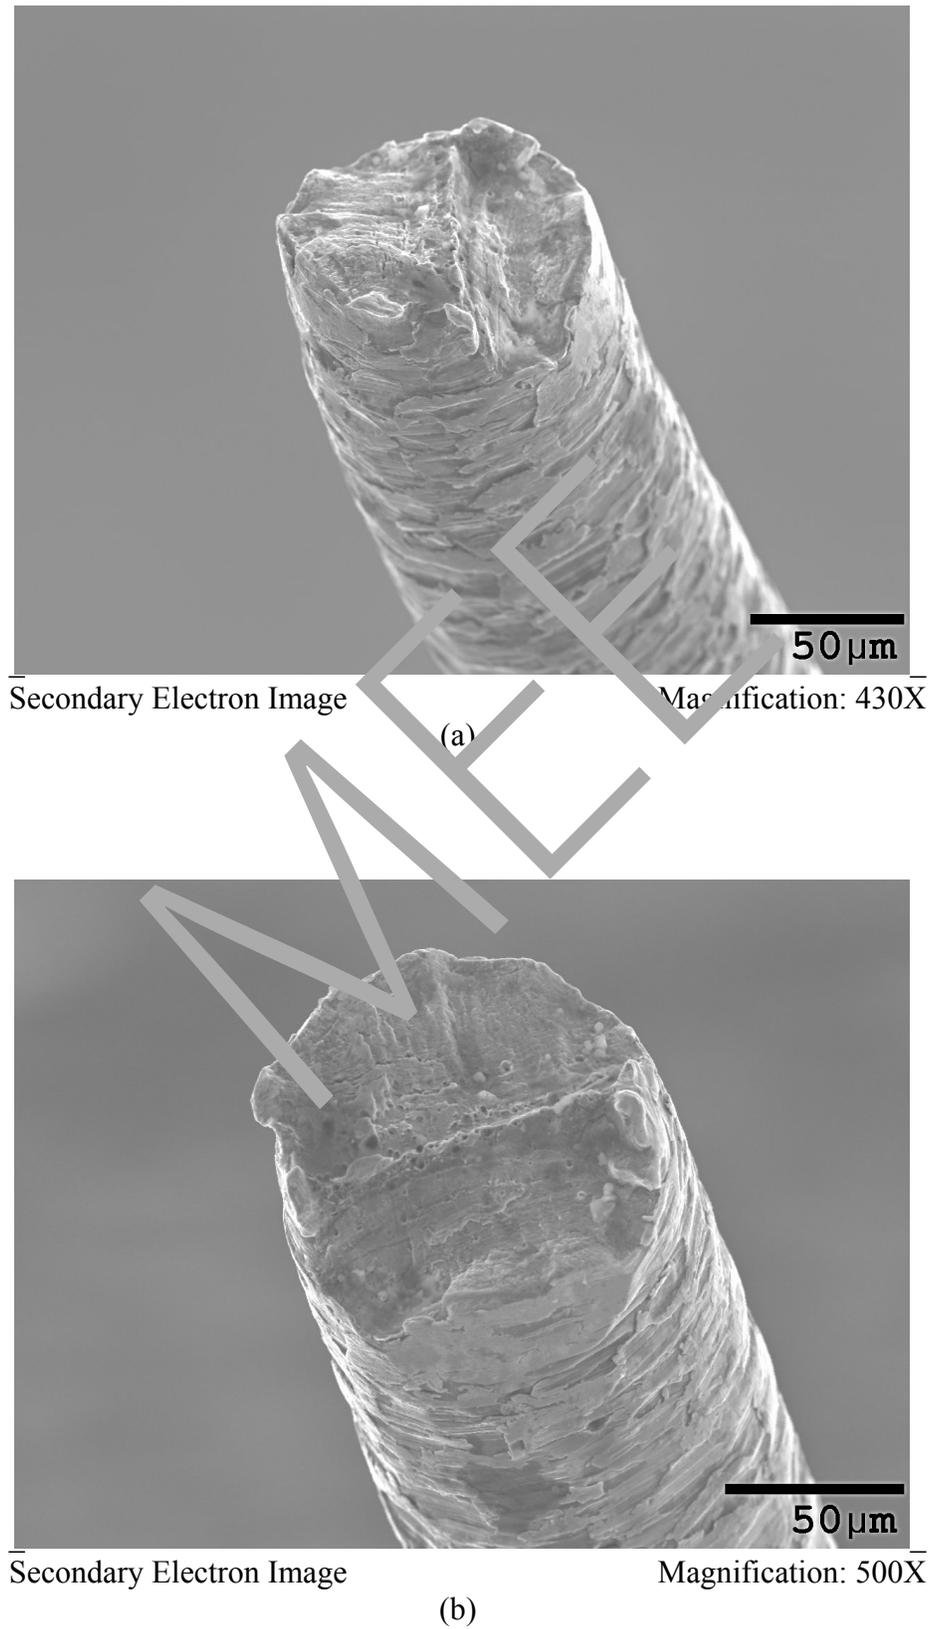
The submitted wire section had a distinct bend in the wire at the fracture. The fracture origins for the two fatigue areas were located at the inside and outside of the bend, which would be consistent with fracture due to reversed bending in the direction of the permanent bend. This bend indicated that the wire had been bent sufficiently that the maximum stresses in the wire were beyond the elastic limit of the wire material. Cyclical bending at this magnitude could readily initiate and propagate the observed fatigue cracks. A permanent bend in the wire may also increase the potential for additional bending of the wire during subsequent manipulation and flexing of the device.

Figure 2 SEM images of the fractured end of the device wire.

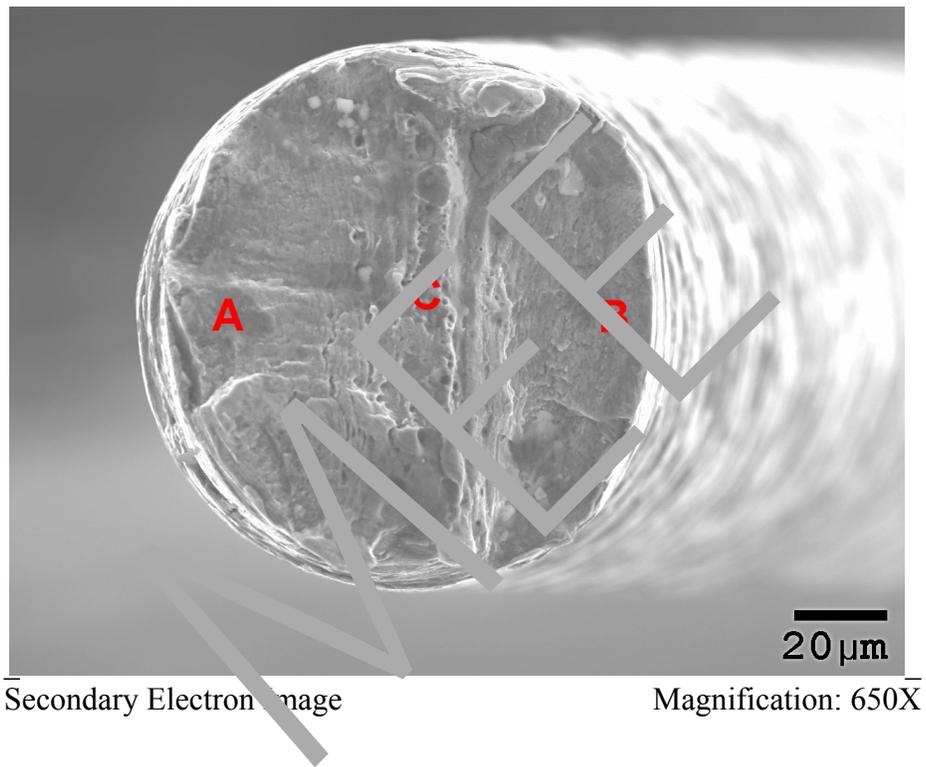
Only one side of the fractured wire was available for evaluation. The fracture surface exhibited three distinct fracture regions. Two fracture zones on opposite sides of the wire exhibited features characteristic of fatigue fracture. Ratchet marks along the wire surface indicated multiple fatigue fracture initiation sites at the wire surface for each of the two fatigue fracture areas.

The third fracture zone was a thin band across the center of the wire between the first two zones. The features in this zone were characteristic of a ductile fracture mode, which indicated that this center zone was the last portion of the cross section to fail.

The fracture had three distinct zones, which are identified as A, B, and C in Figure 3. Zones A and B were relatively flat and located on the outside and inside of the bend in the wire. Striations and secondary cracking on the fracture surface in Zones A and B were characteristic of a fatigue fracture mode. Step-like features, i.e. ratchet marks, in this region indicated multiple crack origins at the surface of the wire for each of the fatigue zones. The orientation of the striations and secondary cracking also indicated fracture propagation generally from the wire surface toward zone C, Figure 4.

Zone C was a narrow band across the wire section in the middle of the fracture between zones A and B. A dimpled fracture morphology in this region was characteristic of a ductile fracture mode.

Figure 3 Fracture surface for the subject device wire.

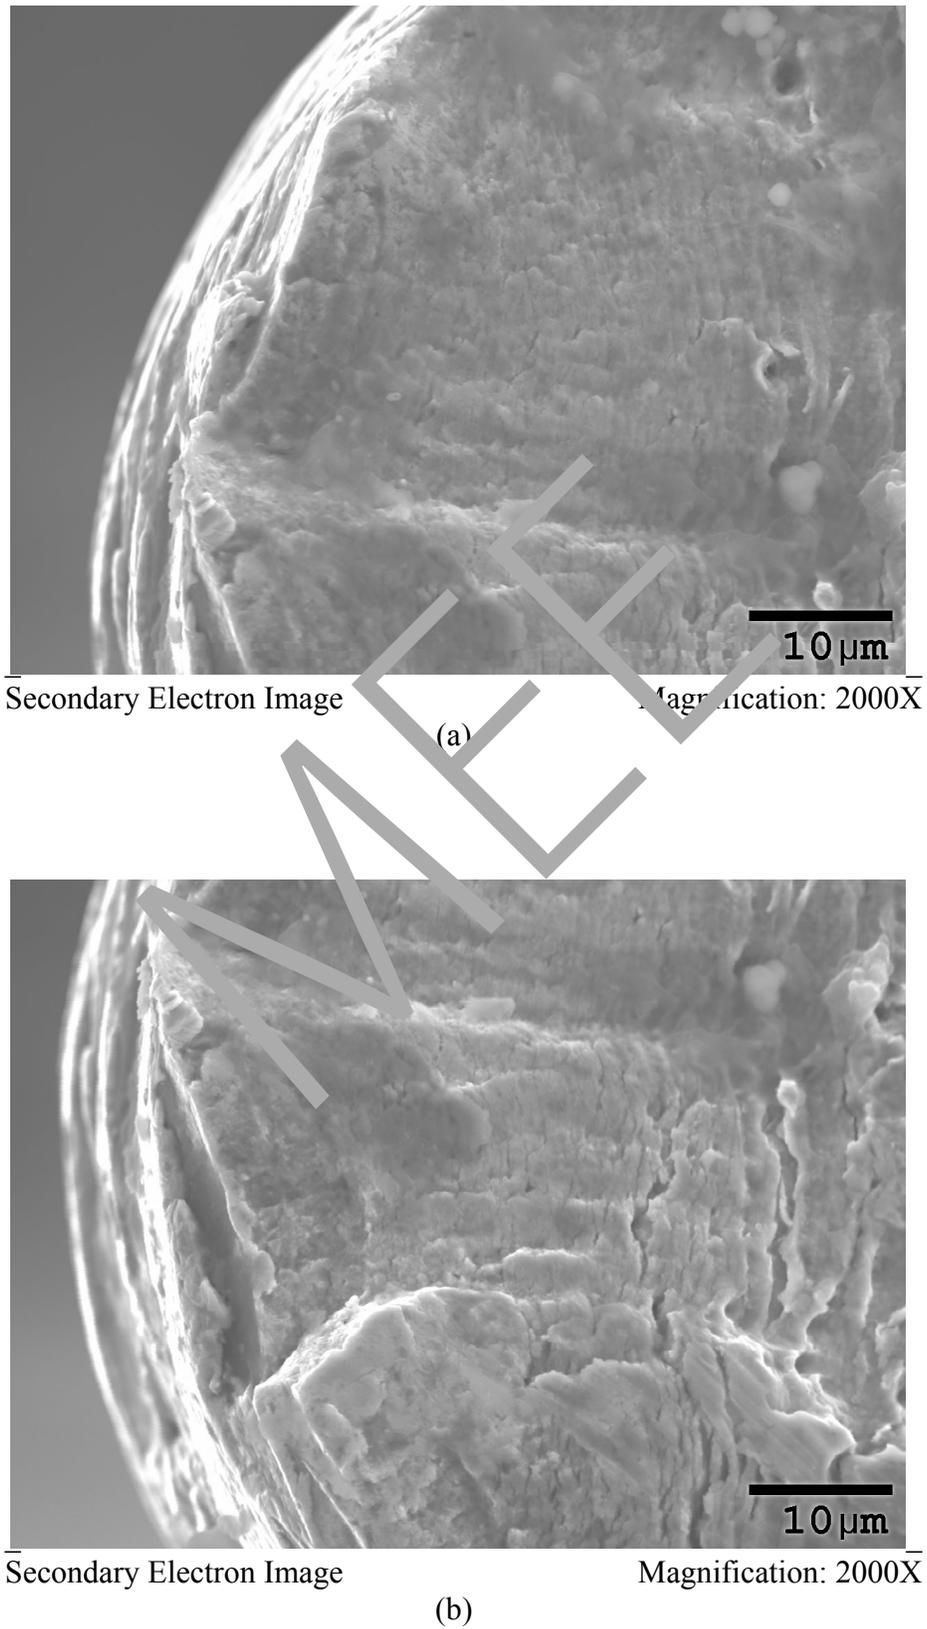
The fatigue fracture mode is a progressive failure mode that requires multiple stress cycles. The width of the fatigue striations on the fracture surface was consistent with a low-cycle fatigue fracture, i.e. the number of cyclical stress cycles to failure ranging from about one hundred to a few hundred. It cannot be conclusively determined from the features of this failure whether the stress cycles that initiated and propagated the fatigue cracks occurred prior to the procedure, during the procedure, or both. Further review of the details of the procedure is recommended to determine when the permanent bend was created and whether a sufficient number of stress cycles could be accumulated during the procedure to have initiated and propagated the fatigue fractures. Review of the manufacturing process for potential sources of cyclical stresses, including the grinding process and turbulent cleaning procedures, is also recommended.

Figure 4 Microscopic fracture features for Zone A of the fractured device wire.
